**US Army Corps
of Engineers®**
Engineer Research and
Development Center

Fluvial Instability and Channel Degradation of Amite River and its Tributaries, Southwest Mississippi and Southeast Louisiana

D. Ryan Hood, David M. Patrick, and Maureen K. Corcoran

September 2007

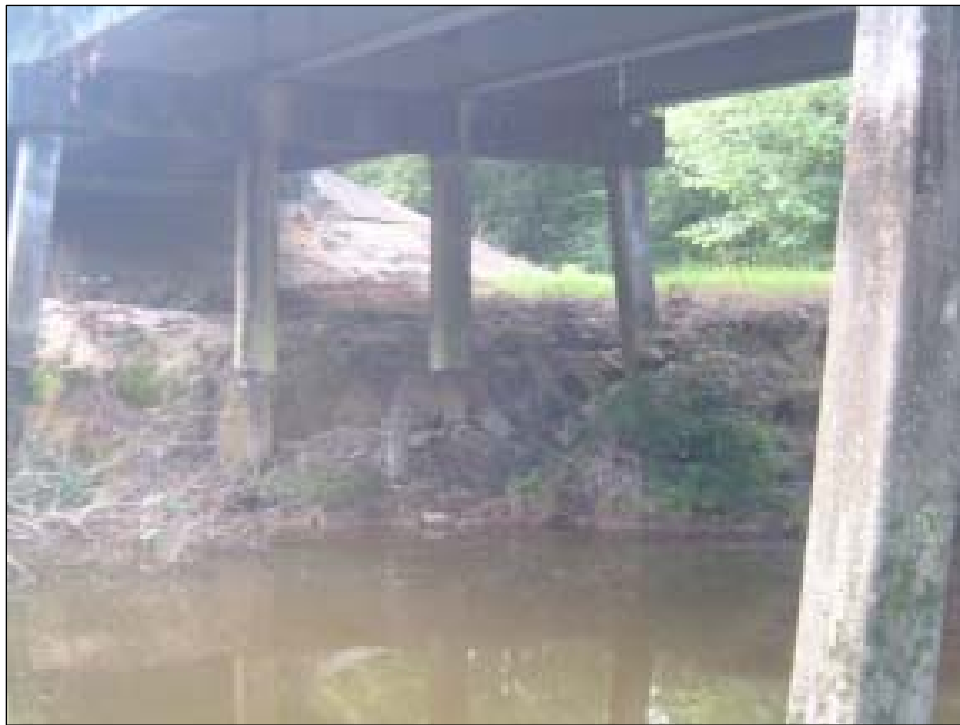
Figure 7. Scour of bridge piers at the Hwy 98 crossing of the East Fork near Smithdale, MS (July 2003).

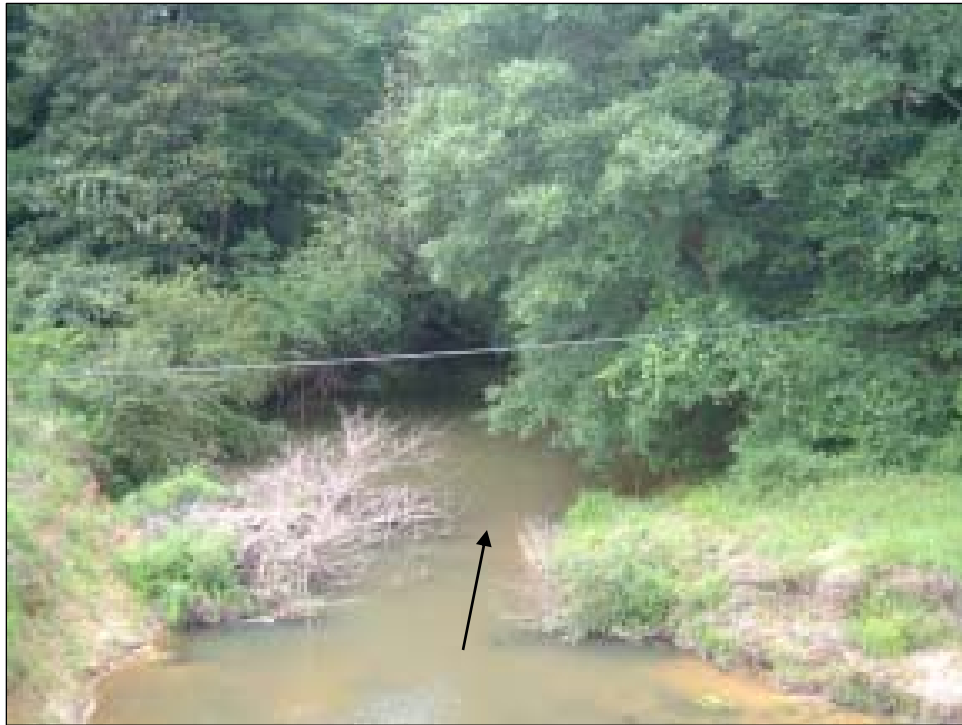
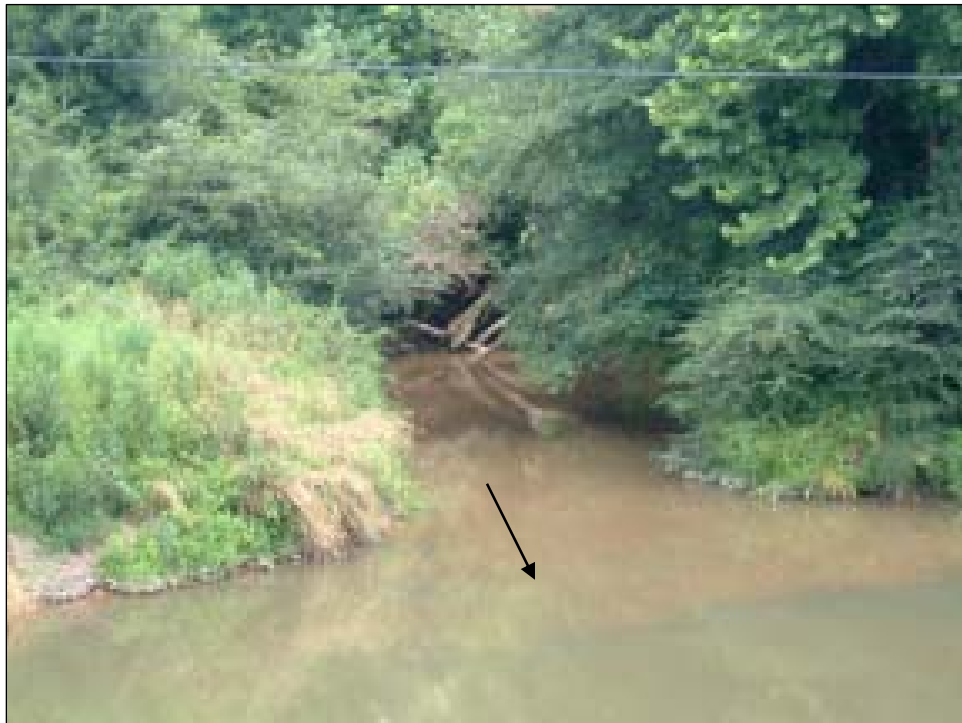
The East Fork Amite River exhibited additional channel instability at the Mississippi Highway 570 crossing near Mars Hill, MS (Figures 8 through 11). At this site, which is approximately 6.4 km downstream of the Mississippi Highway 98 crossing, the channel is still narrow and well vegetated, but there is more leaning vegetation present as well as some dead vegetation in the channel. Both sides of the channel have been over-steepened and excessive, local erosion has occurred.

Figure 8. Downstream view of the East Fork at the Hwy 570 crossing near Mars Hill, MS (July 2003) (arrow notes flow direction).

Figure 9. Upstream view of the East Fork at the Hwy 570 crossing near Mars Hill, MS (July 2003) (arrow notes flow direction).

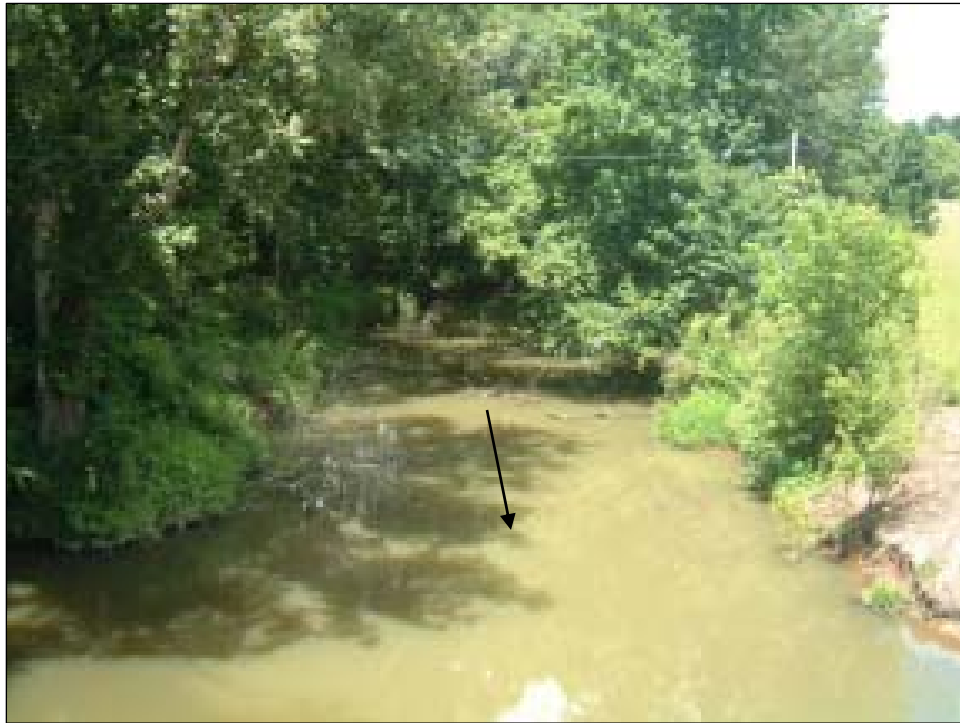
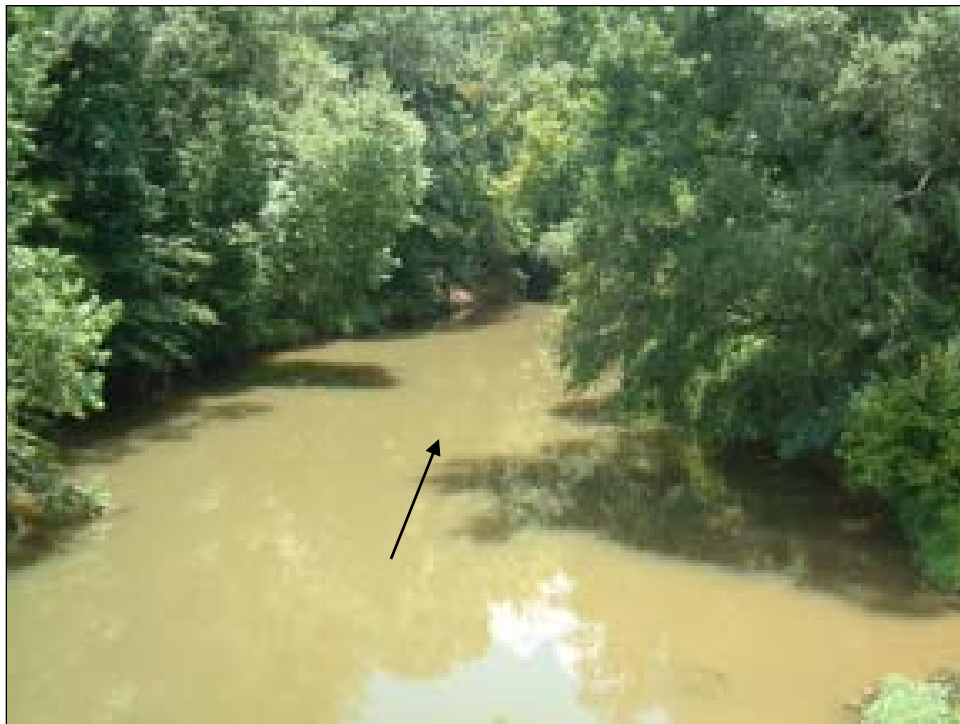
The Mississippi Highway 24 Bridge Crossing near Peoria, MS, is a good example of the East Fork's middle reaches (Figures 12 through 15). The channel has widened, as opposed to the upper reaches, but the banks are still well vegetated. The left (east) and right (west) banks are steep and eroded with the right bank erosion threatening the piers of the Mississippi Highway 24 bridge (Figure 15). Leaning vegetation and vegetation in the channel are present here as well. The channel and bed materials for each of the sites were predominately sand with some silt.

Figure 12. Upstream view of the East Fork at the Hwy 24 crossing near Peoria, MS (July 2003) (arrow notes flow direction).

Figure 13. Downstream view of the East Fork at the Hwy 24 crossing near Peoria, MS (July 2003) (arrow notes flow direction).

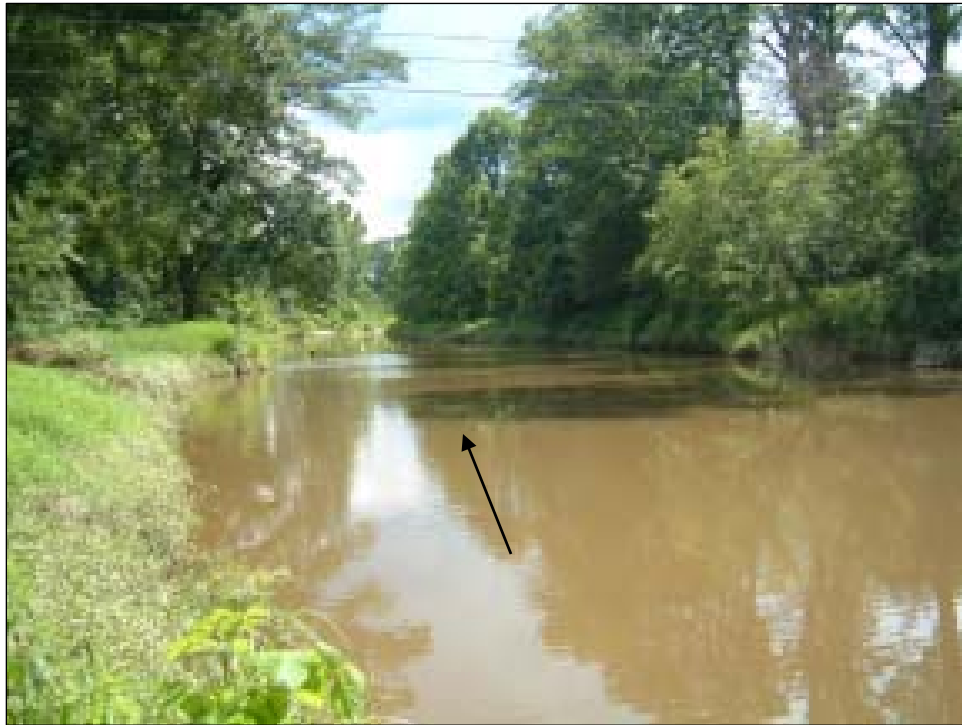
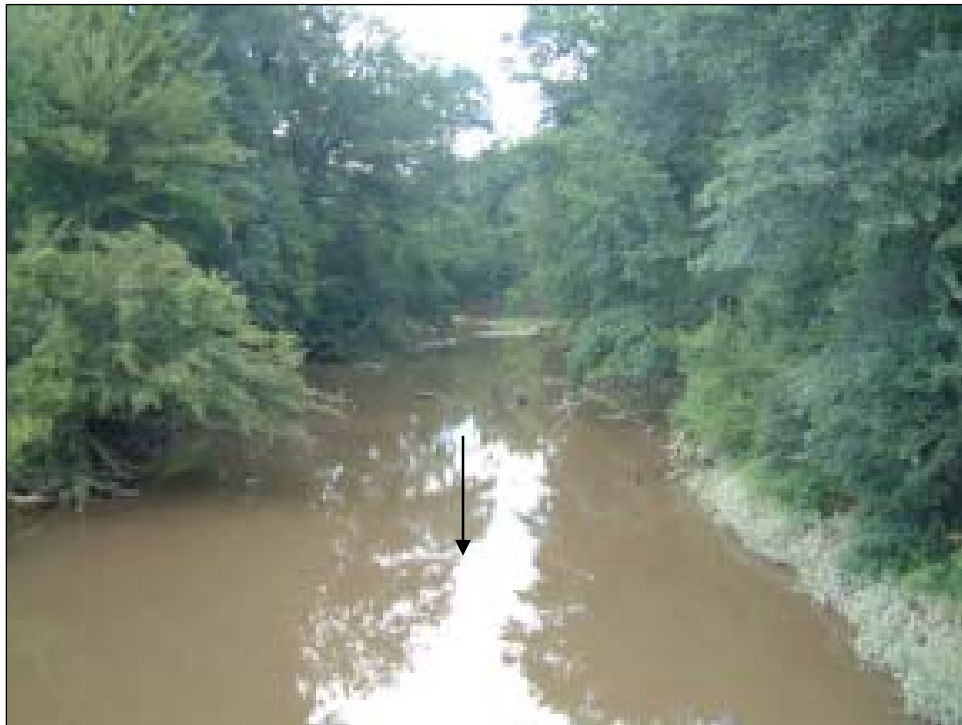
Field observations in the middle and upper reaches of the West Fork Amite, Mississippi Highway 567 (Figures 17 and 18) and Mississippi Highway 24 (Figures 19 and 20) crossings, revealed relatively stable bank and channel conditions. Bank-line vegetation was well established and erosion was minor along these reaches. There was, however, leaning vegetation and a minor amount of vegetative debris in the channel.

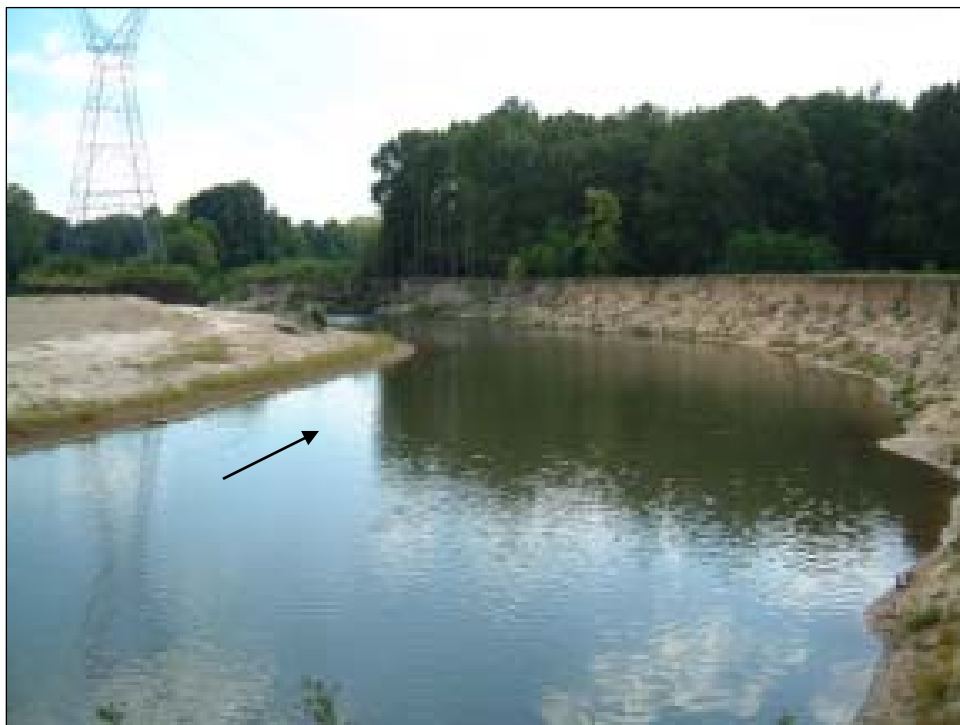
Figure 32. Steep, eroding right bank of the Amite River downstream from the Louisiana Hwy 432 crossing near Felixville, LA (view downstream—September 2003) (arrow notes flow direction).

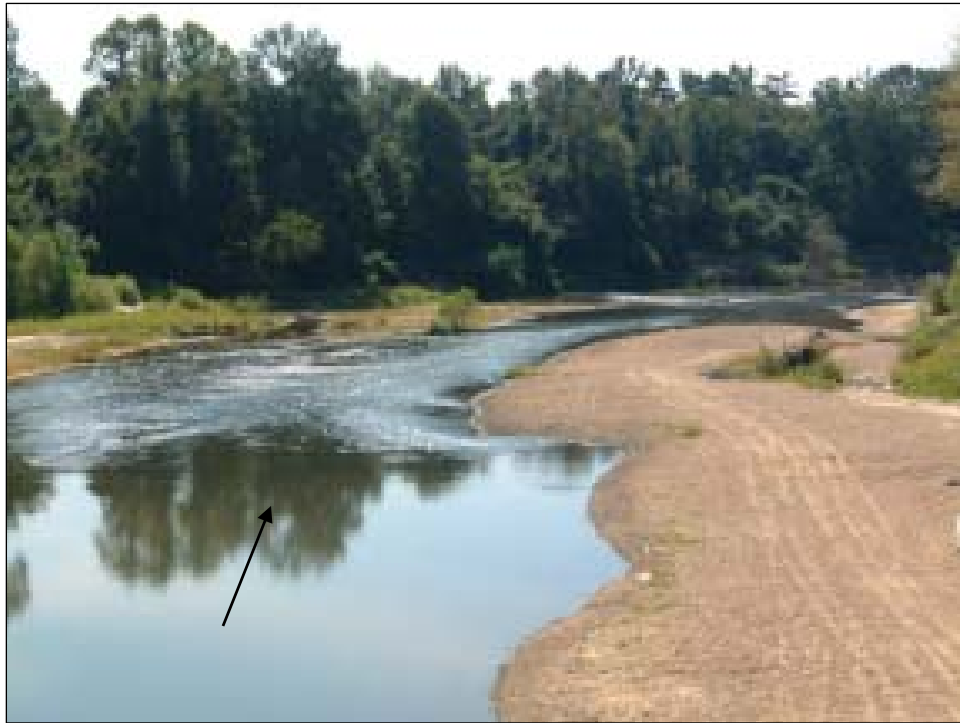
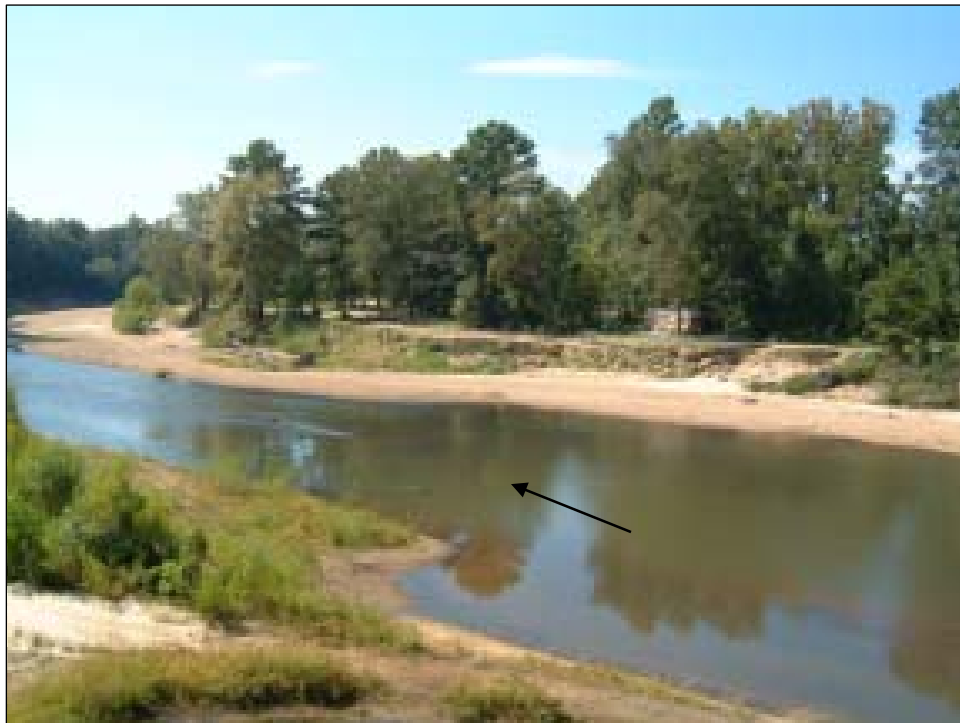
The Louisiana Highway 10 crossing near Darlington, LA, is approximately 9.6 km upstream of the main mined reach. Figure 33 is an aerial view of the bridge. Figure 34 is a ground view upstream and Figures 35 and 36 are downstream ground views. Steep, eroding banks; leaning vegetation; loss of bank-line vegetation; a wide, shallow channel; and divided flow conditions were prominent at this site.

Figure 36. Downstream view of the Amite River at the Louisiana Hwy 10 crossing near Darlington, LA (notice steep, eroding bank behind bar—September 2003) (arrow notes flow direction).

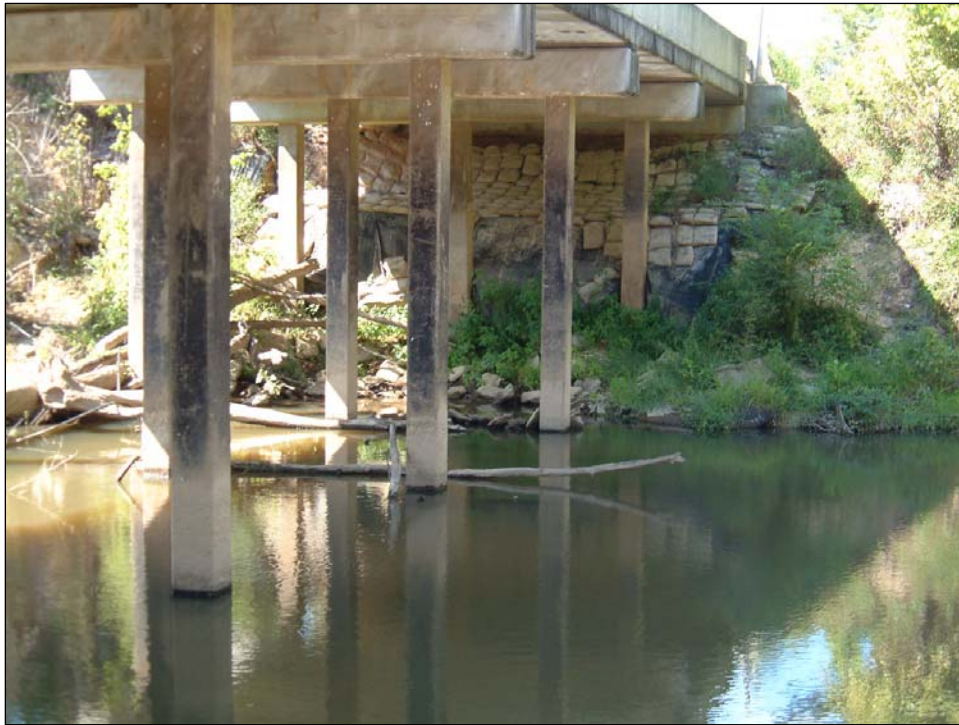
Beaver Creek enters the Amite River from the west in the vicinity of Felixville. At the Perkins Road crossing (Figures 44 through 47), there were signs of channel degradation manifested by steep, eroding banks, leaning vegetation, and dead vegetation in the channel (Figures 44 and 45). A large debris jam formed beneath the Perkins Road bridge (Figure 46) and extends the width of the channel. Erosion protection at the left abutment is apparent in Figure 47.

Figure 47. Left bank bridge abutment of Beaver Creek at the Perkins Road crossing near the Mississippi/Louisiana state line (note erosion control feature—September 2003).

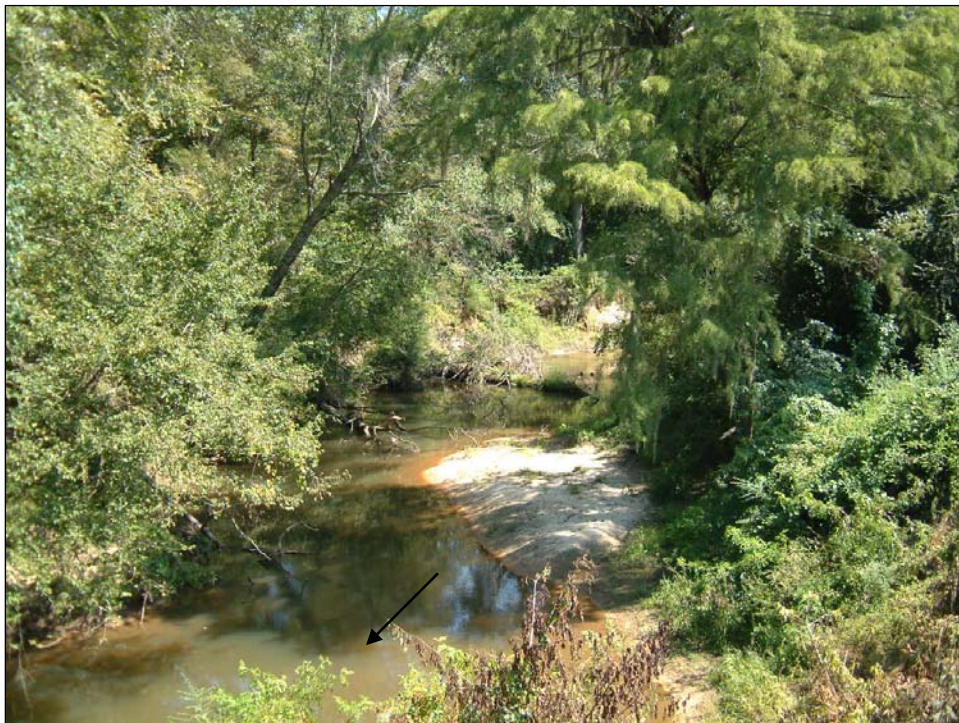
Darling Creek enters the Amite River from the east near Darlington, LA. The Louisiana Highway 10 crossing showed signs of channel instability evident from leaning vegetation, bridge pier damage, debris in the channel, and steep, eroded banks (Figures 48 through 51). Remains of a wooden bridge and undermined banks were also observed. Undermining can cause the bank to become unstable by removing the toe of the bank. At the Louisiana Highway 38 crossing (Figures 52 through 57), bridge piers were scoured and threatened by bed erosion. Undercutting of the right bank was observed and a debris jam was present underneath the bridge.

Figure 48. Upstream view of Darling Creek at the Louisiana Hwy 10 crossing near Darlington, LA (September 2003) (arrow notes flow direction).

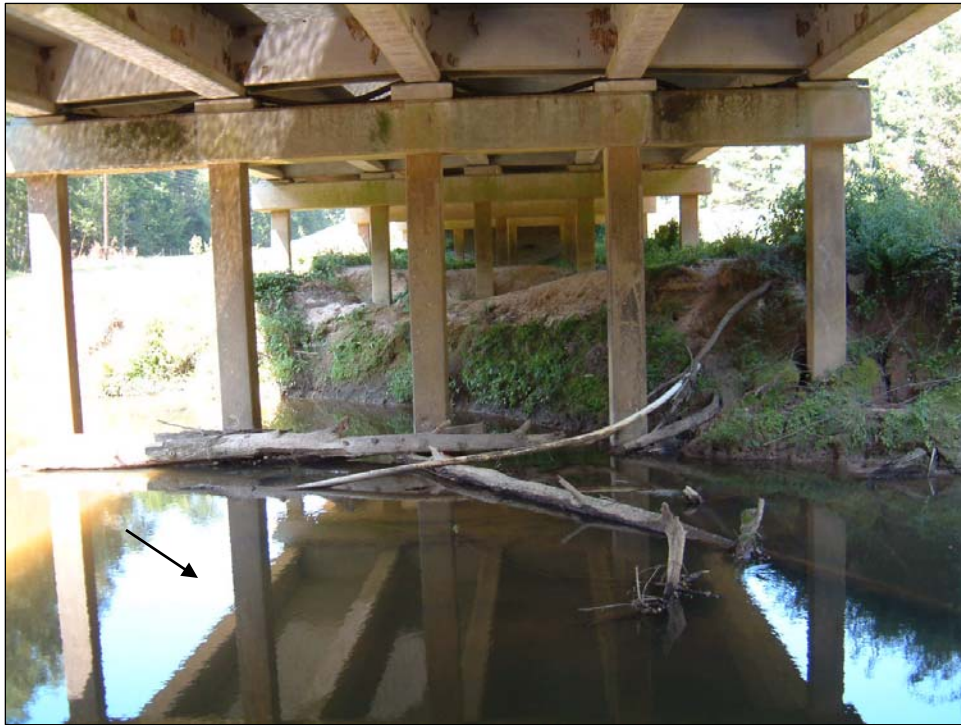
Figure 51. Steep, eroded left bank of Darling Creek at the Louisiana Hwy 10 crossing near Darlington, LA (arrow notes flow direction—September 2003).

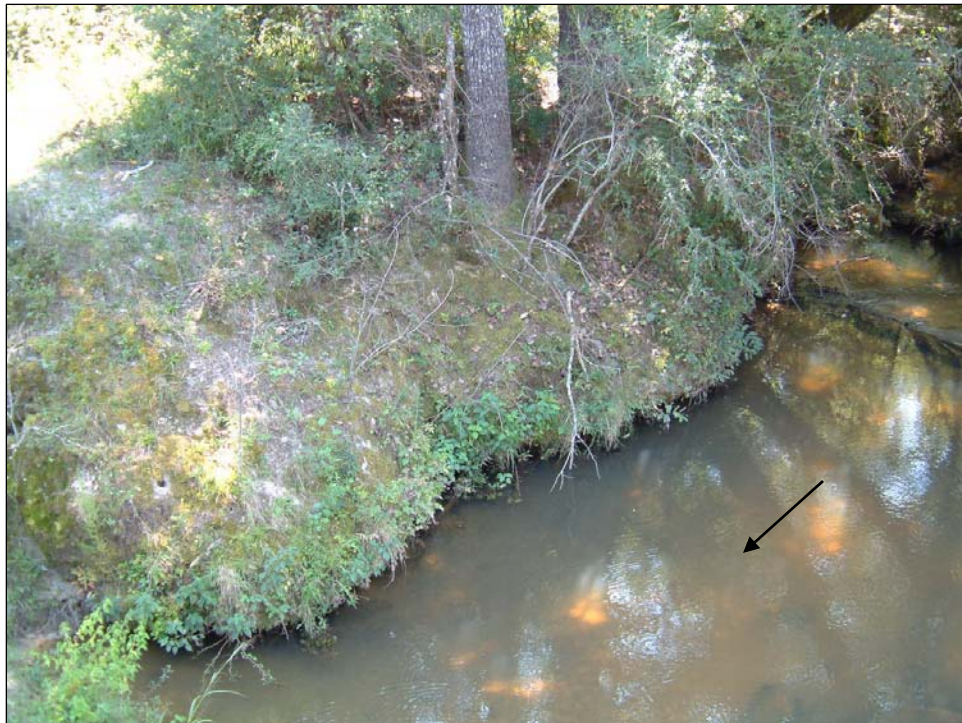
Figure 54. Undercutting of the right bank of Darling Creek at the Louisiana Hwy 38 crossing near Darlington, LA (view is upstream—September 2003) (arrow notes flow direction).

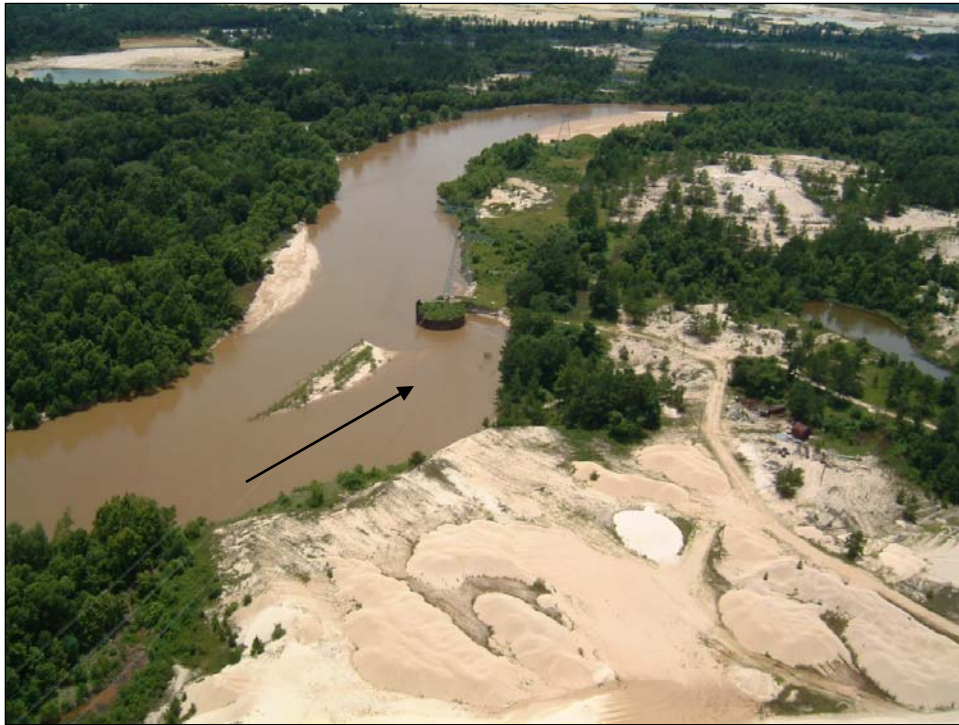
This reach near Magnolia, LA, is actively mined as shown in the 2004 aerial over-flight views (Figures 58 through 61). Figure 58 shows a right-bank mine, which is buffered from the river whereas the right-bank mine shown in Figure 59 does not appear to be buffered, and the buffer of the right-bank mine shown in Figure 60 has been breached. A power transmission pylon surrounded by water is shown in Figure 61. This structure was most likely not constructed in the channel but on the floodplain and the subsequent erosional widening of the channel resulted in the pylon's current location.

Figure 59. Downstream view of the Amite River near Magnolia, LA (note power company pylon in the channel—July 2004) (arrow notes flow direction).

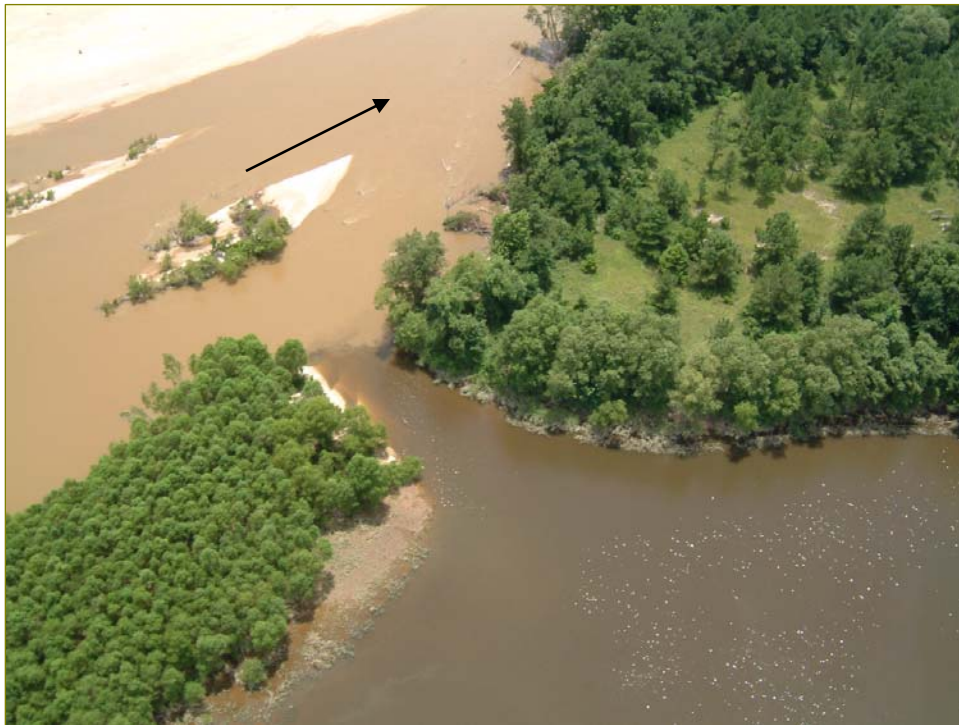
Figure 60. Downstream view of breached right bank of the Amite River near Magnolia, LA (July 2004) (arrow notes flow direction).

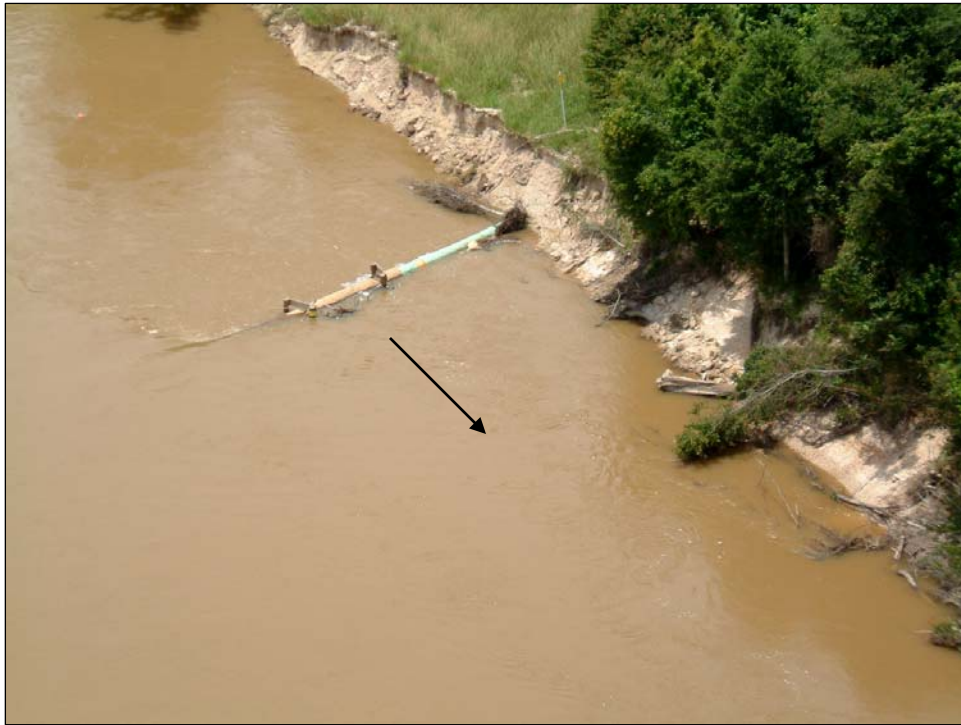
Figure 61. Exposed pipeline and steep, eroding right bank of the Amite River near Magnolia, LA (arrow notes flow direction—July 2004).

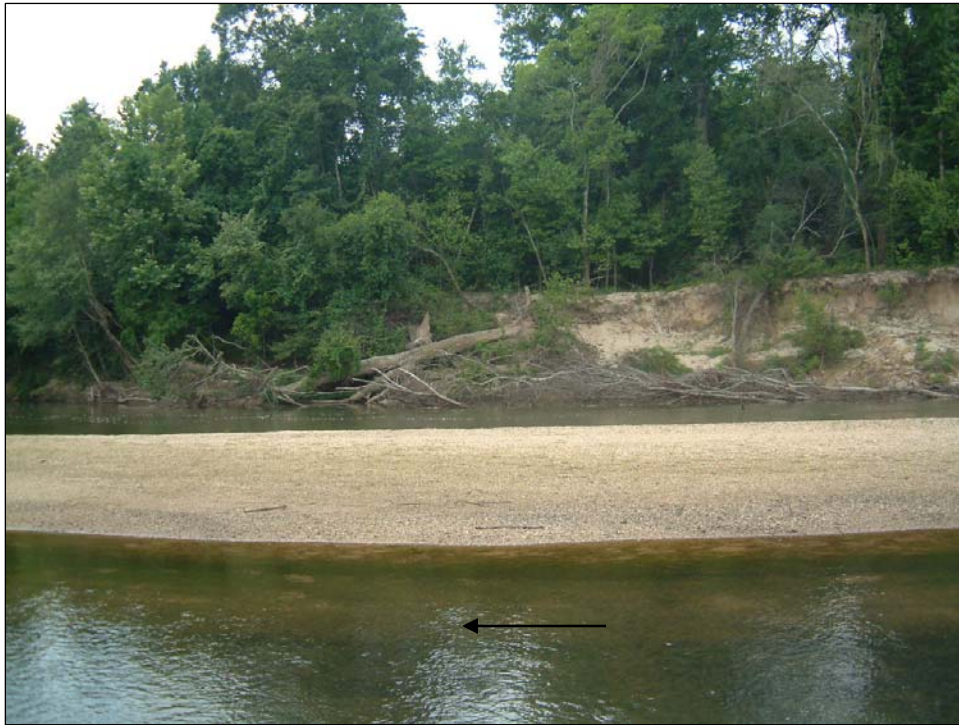
The Amite River channel along this short mined stretch exhibited sand and gravel bars, divided flow, steep eroded banks and loss of bank-line vegetation (Figures 66 through 71). Streambank material consisted of predominately fine-grained sediments, suggesting that the Amite River incised its channel into the Prairie Formation (Figure 69). This fine-grained bank section also exhibited a reddish-brown, approximately 10-cm-thick zone near the waterline (Figure 69). This zone may represent a paleosol within the Prairie Complex. The channel bed material was predominantly sand and gravel.

Figure 66. Large midchannel sand and gravel bar of the Amite River adjacent to gravel mine near Magnolia, LA (arrow notes flow direction—June 2003).

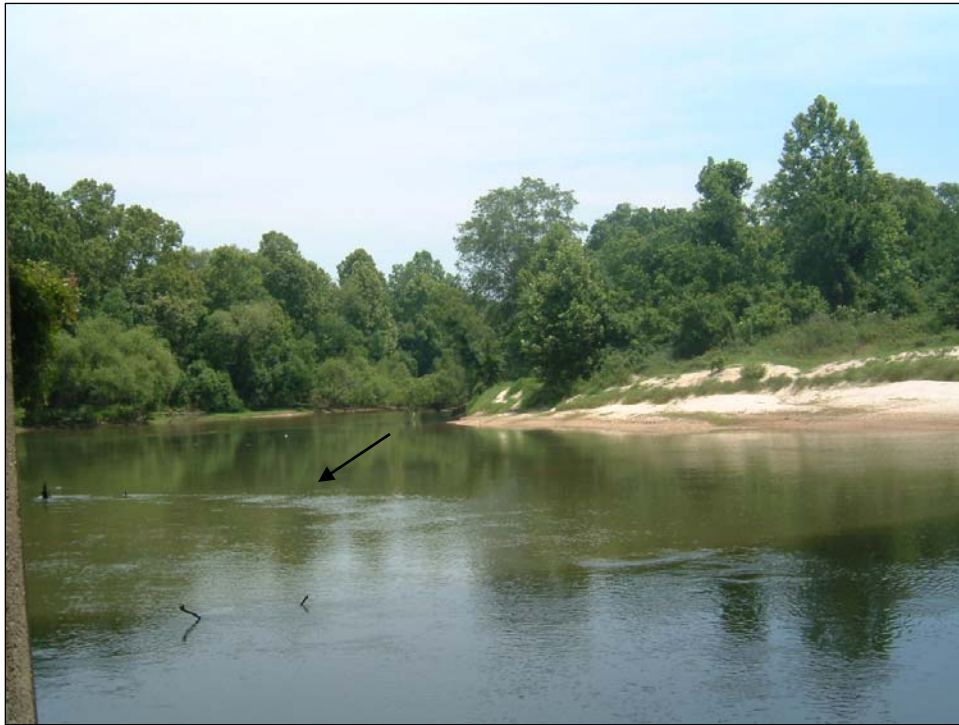
Louisiana Highway 64 crosses the Amite River approximately 4.8 km south of Magnolia, LA, and is within the lowermost part of the main mined reach with gravel mining both upstream and downstream of the site. Locally, the channel was wide and shallow (Figure 72) and exhibited bank erosion, leaning, fallen and uprooted vegetation (Figures 73 through 76), sand and gravel bars, and divided flow (Figures 77 and 78).

Figure 72. Upstream view of the Amite River at the Louisiana Hwy 64 crossing near Magnolia, LA (June 2003) (arrow notes flow direction).

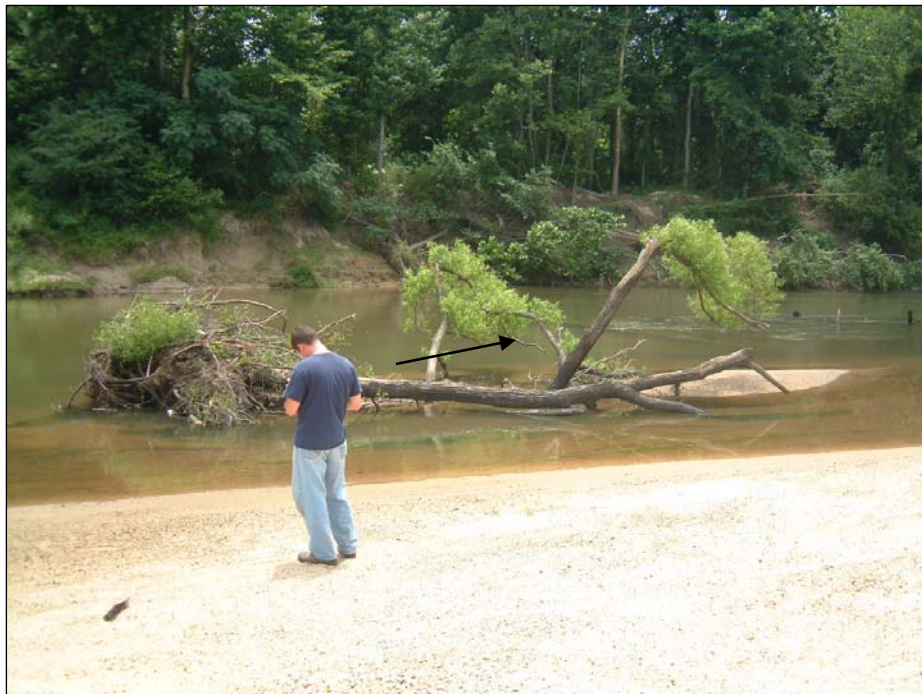
Figure 76. Uprooted tree in the channel of the Amite River just downstream of the Louisiana Hwy 64 crossing near Magnolia, LA (arrow notes flow direction—June 2003).

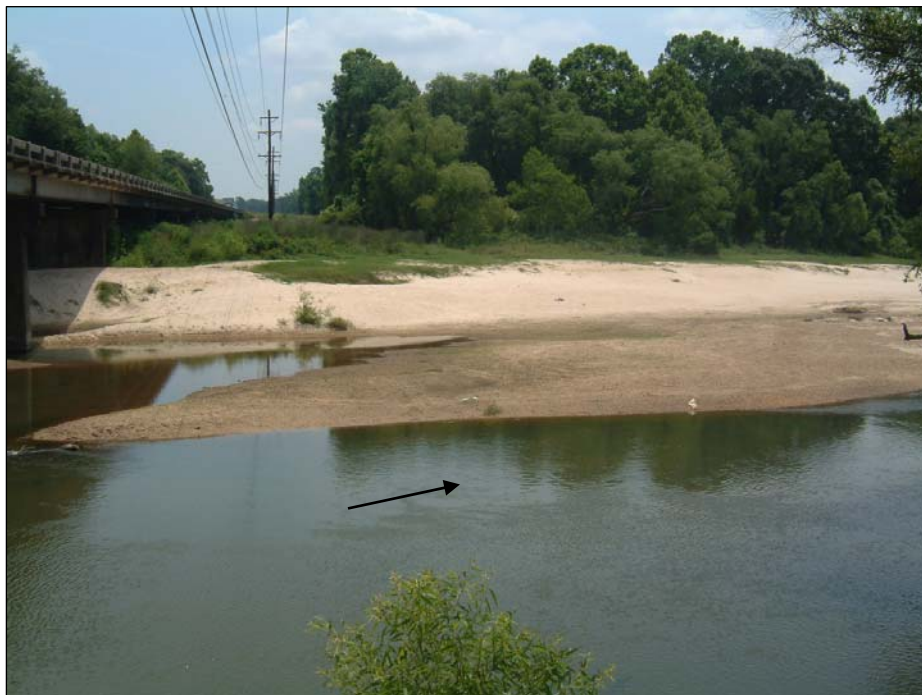
Figure 77. Eroding sand and gravel bar at the Louisiana Hwy 64 crossing of the Amite River near Magnolia, LA (arrow notes flow direction—June 2003).

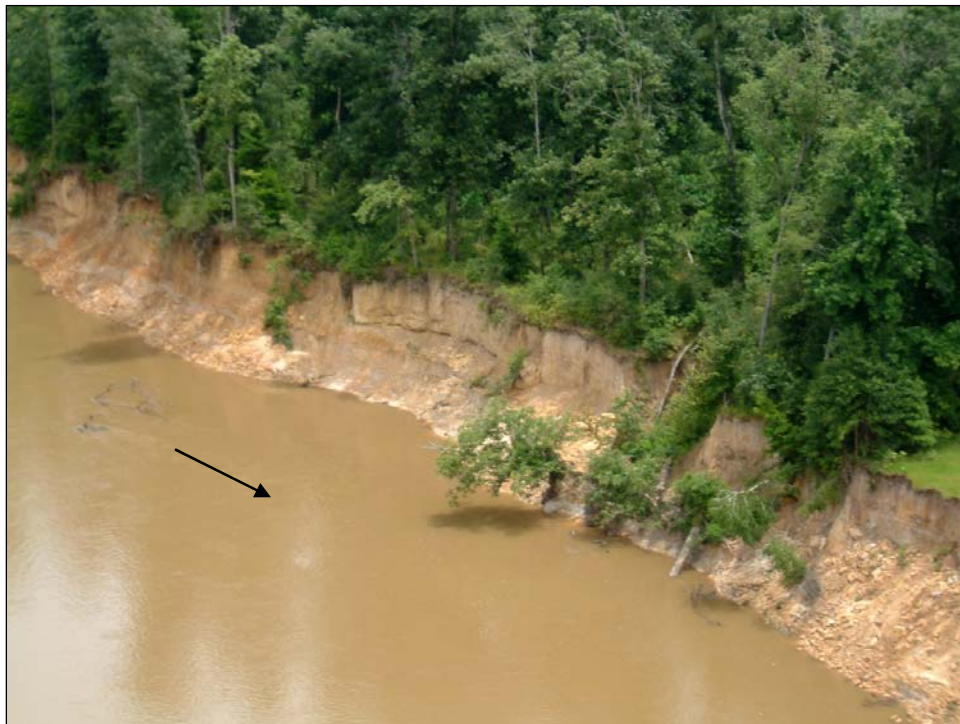
Aerially, channel conditions south of Magnolia and upstream of the Louisiana Highway 190 crossing near Denham Springs (Figure 79) exhibited fewer and more localized indications of instability than in the close vicinity of Magnolia. Bank erosion (Figure 80), divided flow (Figure 81), and point bar development (Figure 82) are apparent in the 2004 aerial views. This decreased level of instability is most likely due to fewer mining operations along this reach. Figure 83 is a 2004 downstream aerial view of the Louisiana Highway 190 crossing showing the confluence of the Amite River and the Comite River.

Figure 80. Steep, eroding left bank of the Amite River just north of Denham Springs, LA (arrow notes flow direction—July 2004).

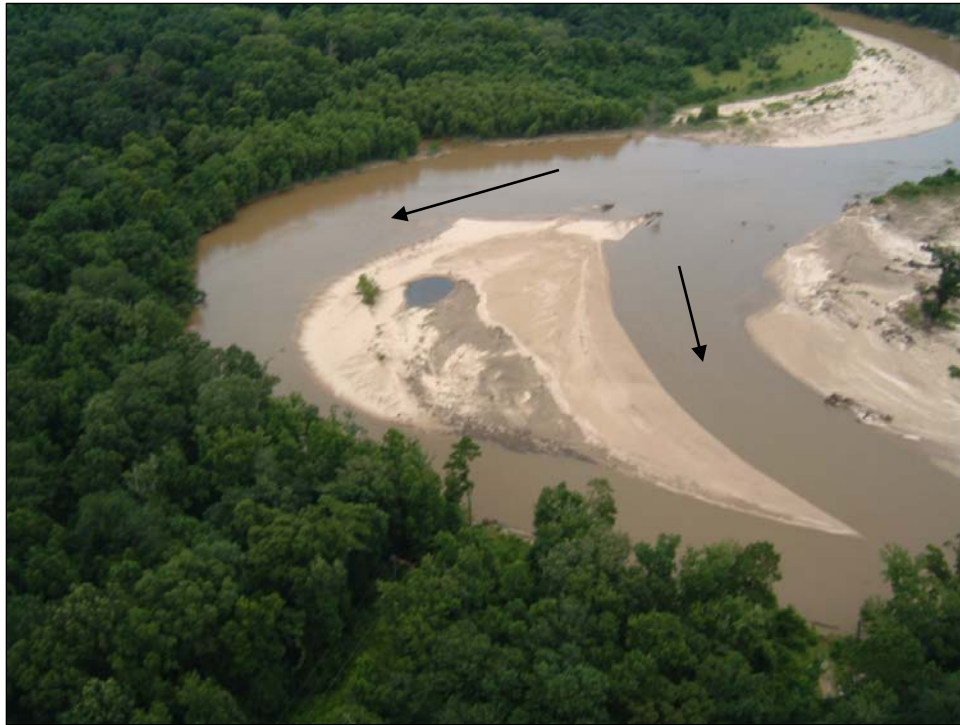
Figure 81. Upstream view of the Amite River north of Denham Springs, LA (note large midchannel sand and gravel bar—July 2004) (arrow notes flow direction).

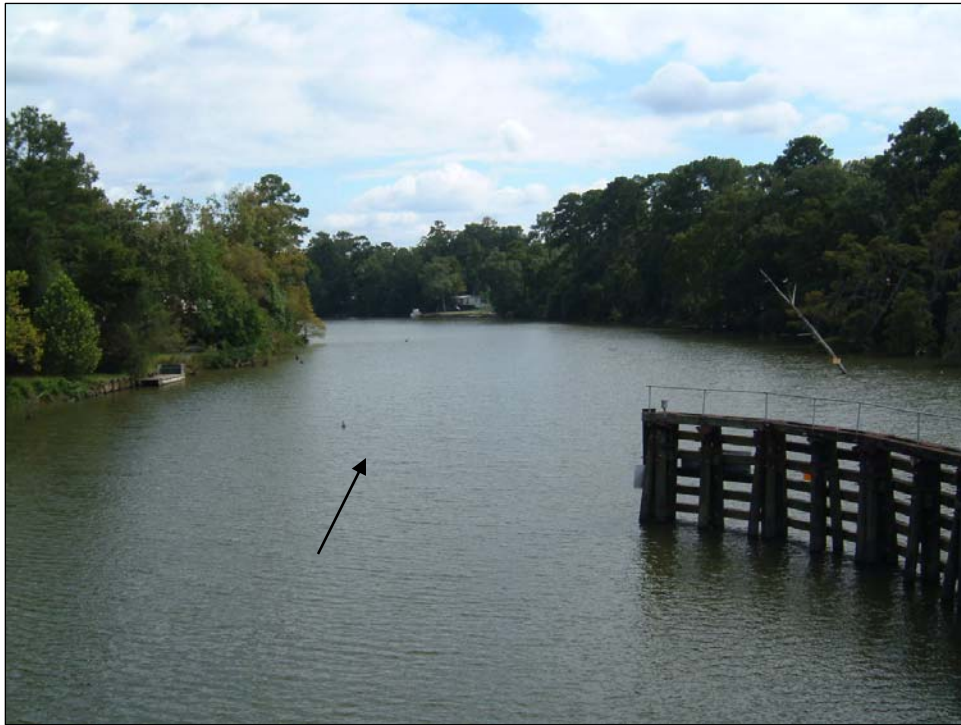
The lower reach of the Amite River was observed from the Louisiana Highway 42 crossing near Port Vincent, LA (Figures 96 and 97). Channel conditions indicated a strong state of stability and reflect the beauty that the Amite River once possessed in its upper and middle reaches prior to gravel mining. Banks are sloping and support thick, mature, healthy stands of mixed deciduous and conifer forests. The basin in this area is virtually flat and composed of poorly drained soils and sediments. As a result, increased flooding is a major problem. This increased flooding may also result from increased water and sediment discharge in the upstream reaches of the river due to urbanization and gravel mining.

Figure 96. Downstream view of the Amite River at the Louisiana Hwy 42 crossing near Port Vincent, LA (July 2004) (arrow notes flow direction).

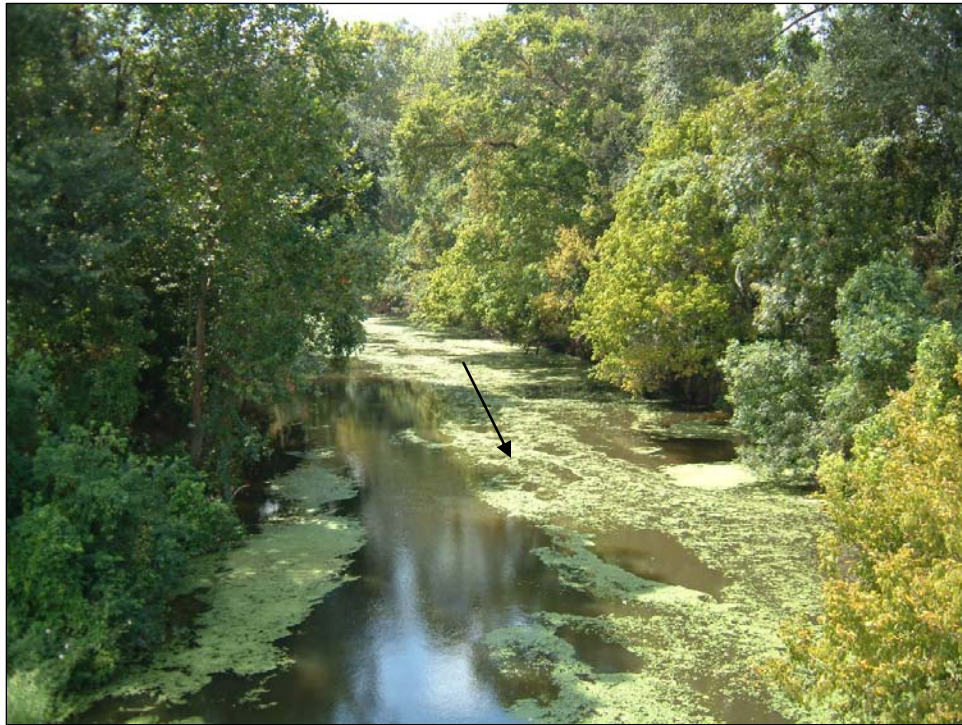
the confluence of Bayou Manchac and the Amite River. Two major crossings were visited on this stream and both revealed relatively stable channel conditions. The I-10 crossing (Figures 98 and 99) and the Louisiana Highway 61 crossing (Figures 100 and 101) cross Bayou Manchac just south of Baton Rouge, LA. Moderately sloping, well vegetated banks were observed at both locations although there were some minor signs of leaning vegetation present. The channel appeared to be rather straight with no bar development at either site. If instability is occurring or has occurred along this stream, then it is minor.

Figure 99. Upstream view of Bayou Manchac at the I-10 crossing near Baton Rouge, LA (July 2004) (arrow notes flow direction).

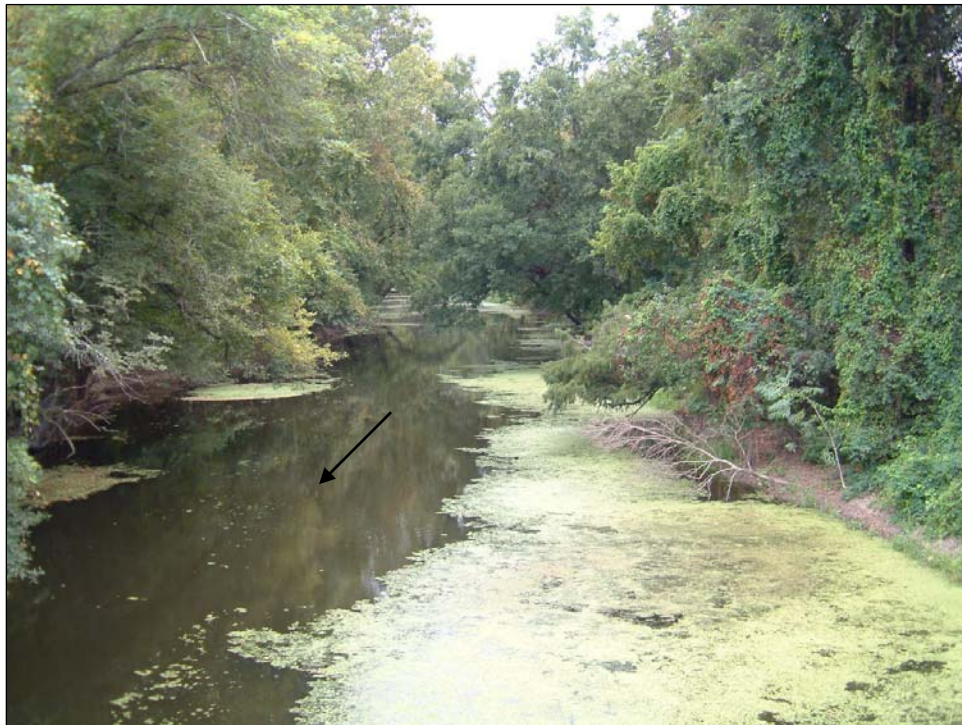
Figure 100. Upstream view of Bayou Manchac at the Louisiana Hwy 61 crossing near Baton Rouge, LA (July 2004) (arrow notes flow direction).

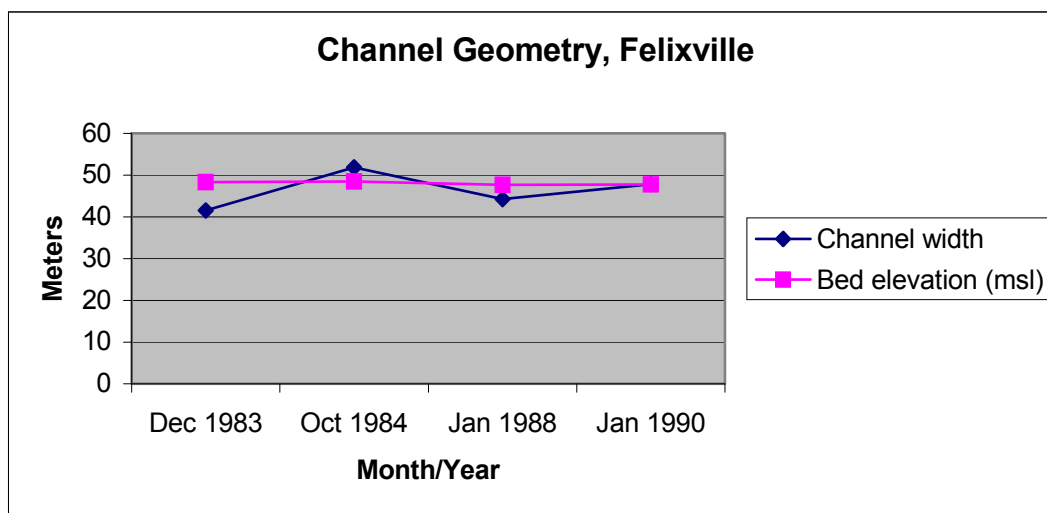
Figures 102 through 106 are plots of channel width and deepest channel elevation (thalweg) versus time at the five surveyed bridge crossing sites. In each plot, values of width and channel elevation are averaged for the three survey points upstream of the bridge. In general, each plot illustrates an increase in channel width. The increased channel width is more pronounced with distance downstream. Channel elevation, on the other hand, has remained mainly unchanged over time. Channel width change data are summarized in Table 1.

Figure 102. Channel width and bed elevation versus date at the Felixville crossing.

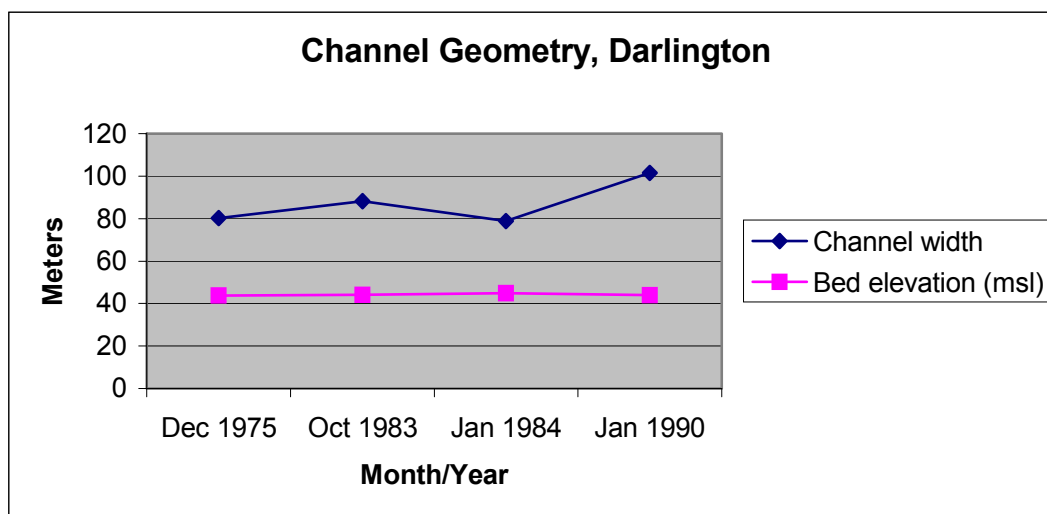
Figure 103. Channel width and bed elevation versus date at the Darlington crossing.

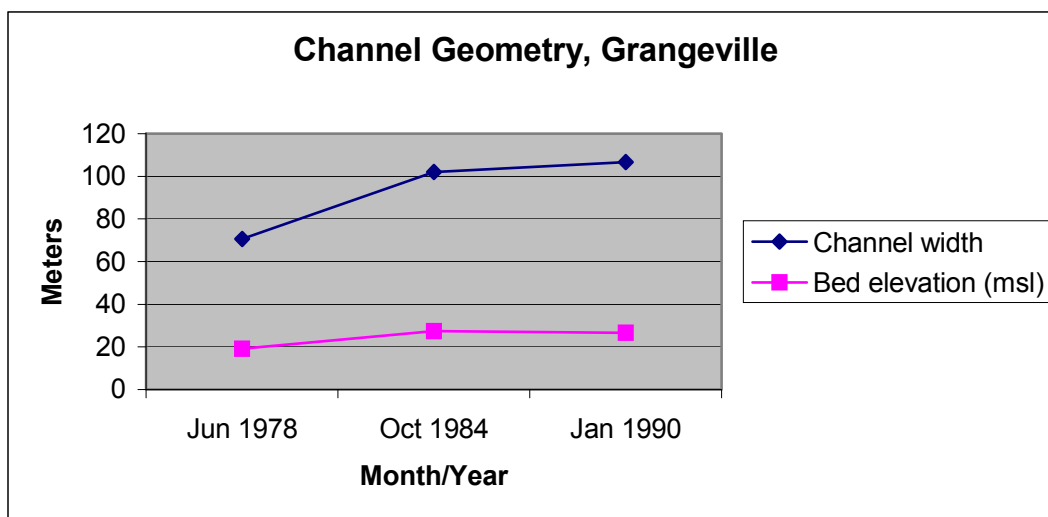
Figure 104. Channel width and bed elevation at the Grangeville crossing.
